Manhole Inspection Summary

Manhole # S01WW1007MH

Insp Date: **9/19/06 12:58 PM**

Location Address: **6006 PARKINGTON AVE**

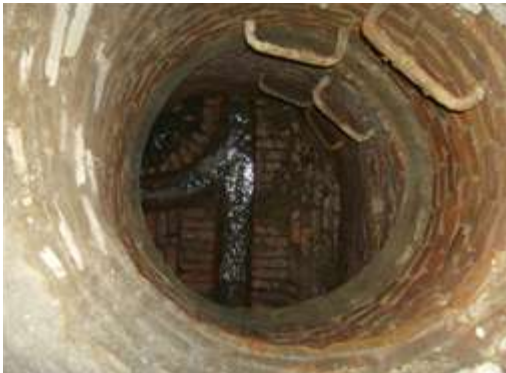
Top View

Corroded steps.

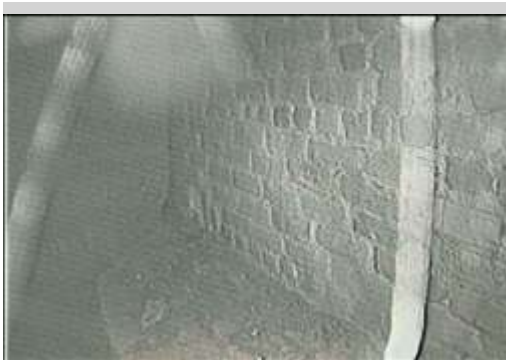
unknown connection

I5?

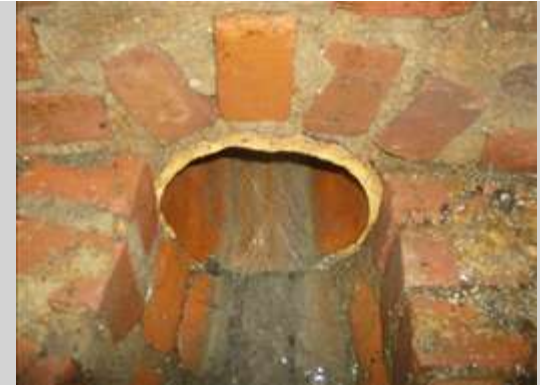
8 in. Circular Gravity Sewer Pipe Out @ 12 O'Clock

Invert Depth: **11.28** (ft.) Flow Characteristics: **Slow**

Deposits: ☒ None ☐ Mud ☐ Sludge ☐ **Debris** ☐ Grease

Infiltration: **None** Pipe Seal Cond: **Sound**

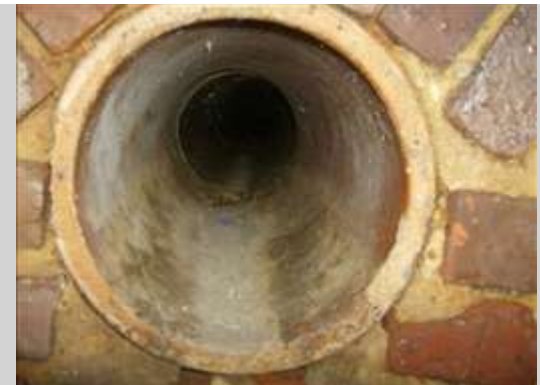
8 in. Circular Gravity Sewer Pipe In @ 3 O'Clock

Invert Depth: **7.15** (ft.) Flow Characteristics: **None**

Infiltration: **None** Pipe Seal Cond: **Sound**

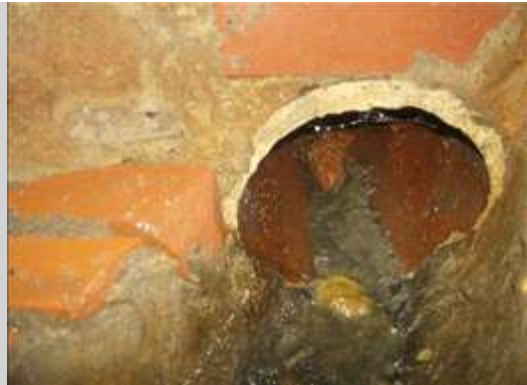
Pipe In @ 6 O'Clock

Invert Depth: **11.10** (ft.) Flow Characteristics: **Slow**

Deposits: ☐ None ☐ Mud ☐ Sludge ☒ **Debris** ☐ Grease

Silt Depth: **1** (in.) Deposits Extent: **Light**

Connects To: **Dead End**

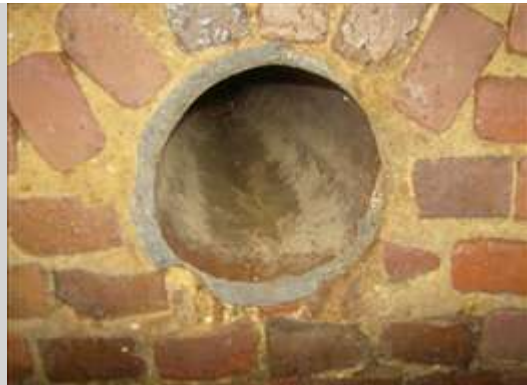
Pipe In @ 9 O'Clock

Invert Depth: **7.14** (ft.) Flow Characteristics: **None**

Infiltration: **None** Pipe Seal Cond: **Sound**

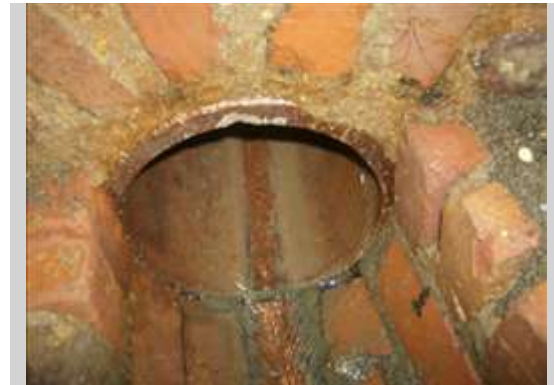
Drop In @ 9 O'Clock

Drop: **Outside** Rod and Bar

Drop Condition: **Open**
